Health evaluation of Kedangpahu watershed in relation to flood problem at Kutai Barat Regency

Key words: Health evaluation, Flood, Kedangpahu Watershed, Geographic Information System (GIS).

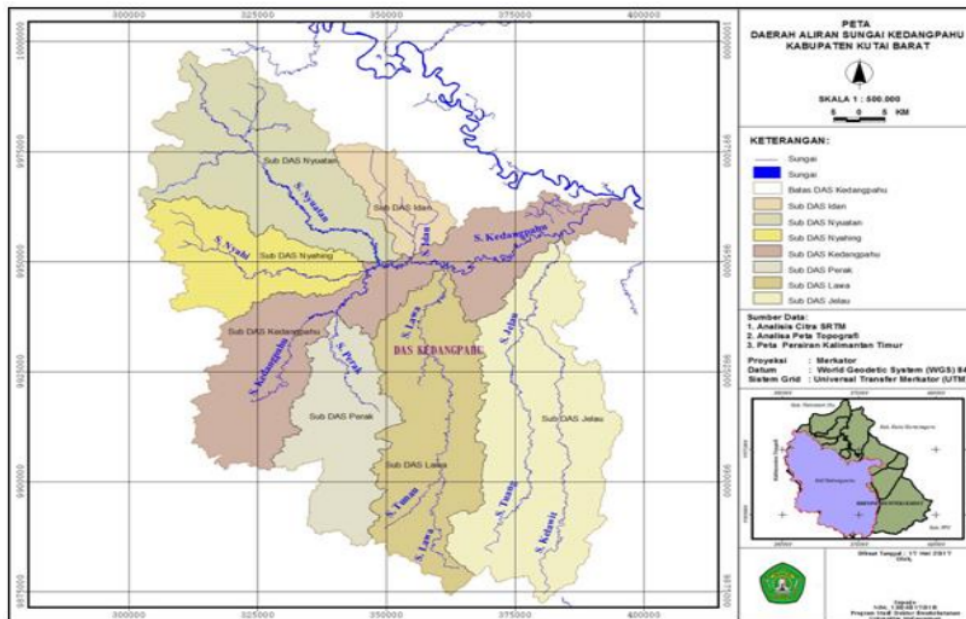
Fig. 1. Location of Kedangpahu Watershed.

The study was held at Kedangpahu watershed in Kutai Barat Regency, East Kalimantan. The study area covered 698,952 ha. Geographically it was laid between 115°13'12" - 116°05'24" eastern and between 00°1'12" - 00°09'00" southern. Graphically, the study area could be seen at Fig. 1.

It can be said that Kedangpahu watershed is the big watershed in East Kalimantan. If the rainfall is high in all over area of Kedangpahu the flood must occur in this area. It consists of seven sub watershed in succession; they are Idan 29,666.72 ha, Nyuatan 120,181.9 ha, Nyahing 64,083.09 ha, Kedangpahu 140,506.4 ha, Perak 70,540.69 ha, Lawa 113,654.42 ha, and Jelau 160,318.02 ha, graphically as shown in Figure 1. Jelau is the largest sub watershed among of them.

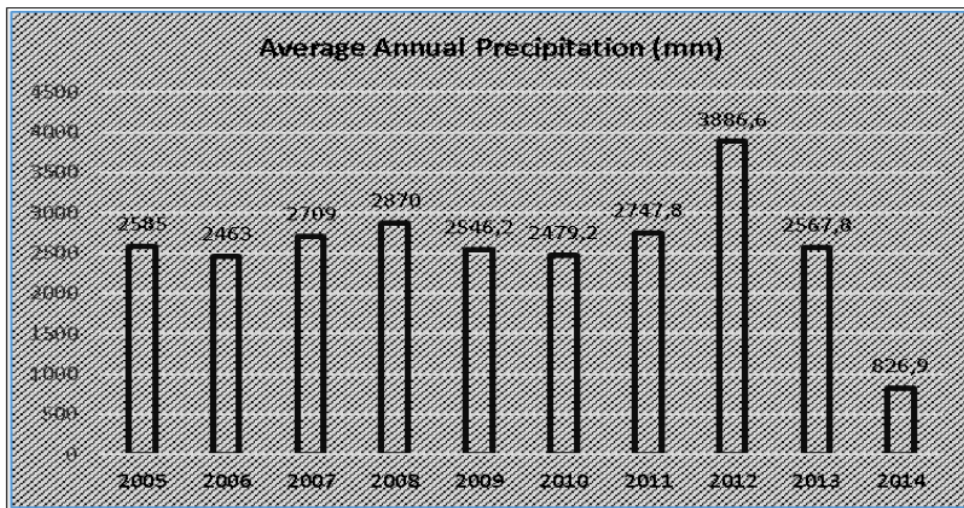
Fig. 2. Average annual precipitation.

Air temperature laid between 28,63°C to 27,24°C. The highest average relative humidity is 86.17% and the lowest 79.10%. Average precipitation is 2,568.2 mm/year with maximum 3,886.6 mm/year and minimum 826.9 mm/year as seen in Fig. 2. Base on this figure the highest one occur on the year of 2012. While monthly average precipitation could be seen in Fig. 3. Base on this figure the highest precipitation occur on December.

on December, it means that the flood possibility occurred in December is high. During the days with precipitation reaches the highest point, flooding will occur. Year of 2012 precipitation data indicated the highest one. While monthly precipitation indicated that December was the highest point reaching 376.72 mm and occur until January. Discharge of Kedangpahu river in 2012 laid from 355.5 m³ to 610.6 m³. Figure 4 indicated the trend of discharge which shows an increasing year by year.

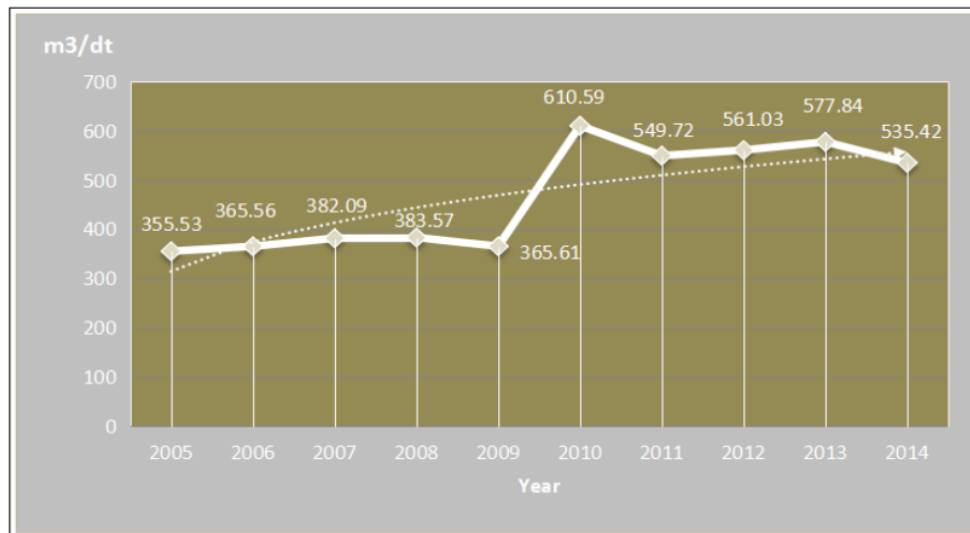
Fig. 4. Average discharge of lately ten years.

In general the condition of discharge can be seen at Figure 4. According to Figure 4 the discharge of Kedangpahu river tend to increase from year by year from 2004 to the year of 2014. While from Figure 3 could be seen the highest precipitation occurred at December.

It is linear with land cover degradation condition. Uncontrolled deforestation in sub watersheds increases discharge of Kedangpahu river. Average of water regime index of the last 10 years reached 2.34 point. It means that in arid season the water discharge lower than in rainy season. Al-Bakri *et al.* (2013) stated that problems of water scarcity and food insecurity would be exacerbated by climate change and increased population growth. His study held in Jordan in relation to water and food security.
