9th ASIAN ROCK MECHANICS SYMPOSIUM

"Harmonizing Rock Mechanics with Sustainable Economic Development"

Implementation of Study Rockfall Hazard Rating System (RhRS) Method for Slope Stability Analysis at Samarinda Seberang District, East Kalimantan, Indonesia

Rock Slopes Stability Evaluation Based on Comparison Empirical Methods "Slope Mass Rating" and Analytical Method at Discontinuities Rock Mass Condition (Case Study at Sandstone Mines, Tani Aman Village, Loa Janan Sub District, Samarinda, East Kalimantan, Indonesia)

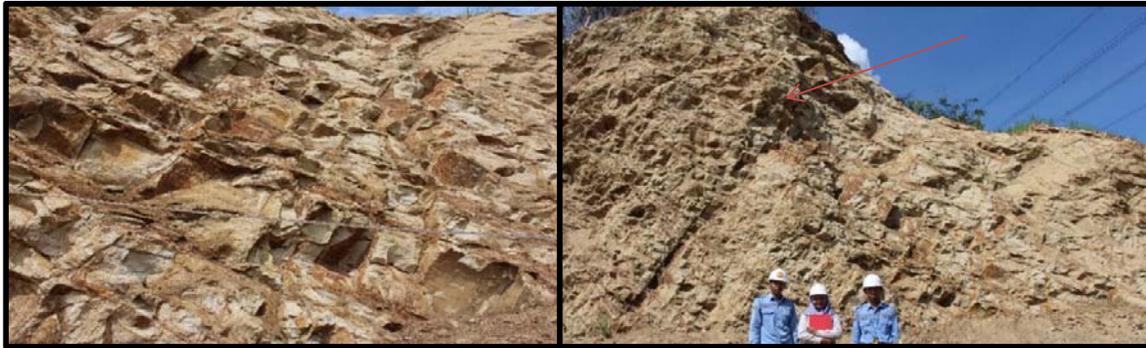
Fig. 2. Study Site

Measurement of joint structure carried on the slopes. The slopes have a 10 m height, and the angle is about 33°. From the measurement results obtained joint closeness spacing between 2.27 to 0.33 cm, with the average joint spacing is 1.07 cm. Joint intensity on the bottom. In the fair condition, the water flow is only a minor seepage, but when it rains the flow is large enough.

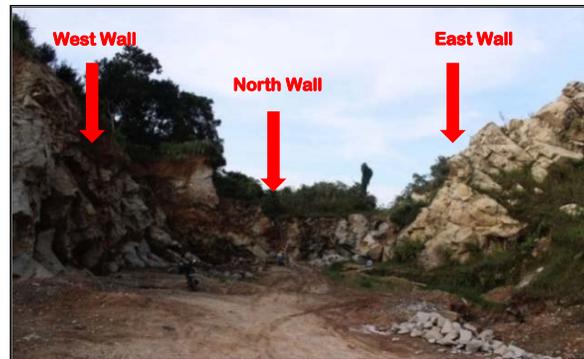
Fig. 2. Sandstone Mines Location

Mining process at the site of this study area mined by conventional manner and using traditional equipment and carry out by the communities surrounding the mine area as shown Figure 2. In the process, sandstone mining in this study sites have no certainty about the mining slope stability. It is deemed very important to do studies on slope stability in sandstone mining area. Based on observations in the field, there are of discontinuities intersecting each other on the sandstone. And this discontinuities can potentially cause instability in the mining slopes.
