# Health evaluation of Kedangpahu watershed in relation to flood problem at Kutai Barat Regency

## Health evaluation of Kedangpahu watershed in relation to flood problem at Kutai Barat Regency

**Key words:** Health evaluation, Flood, Kedangpahu Watershed, Geographic Information System (GIS).

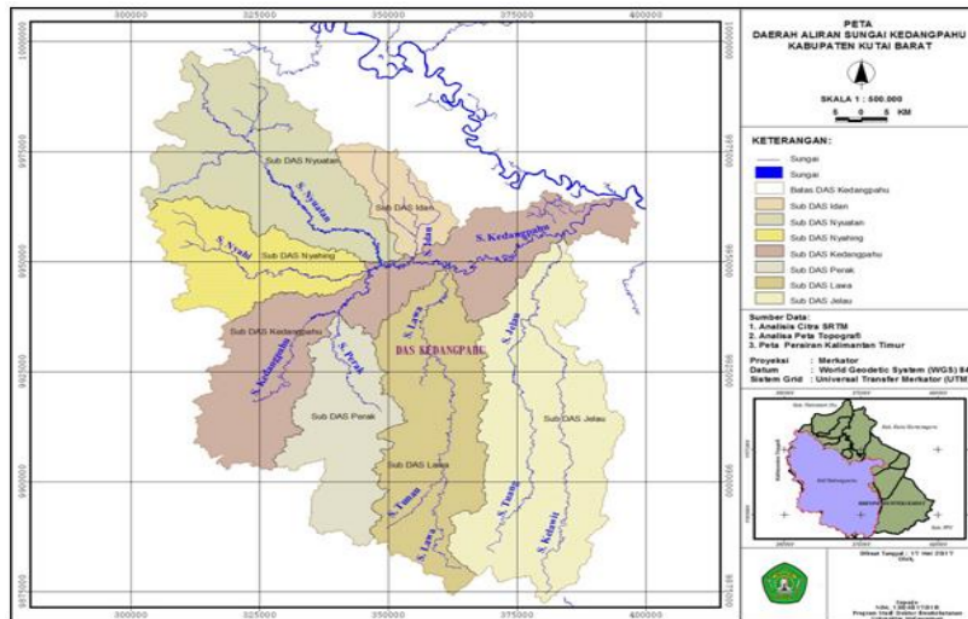
Fig. 1. Location of Kedangpahu Watershed.

The study was held at Kedangpahu watershed in Kutai Barat Regency, East Kalimantan. The study area covered 698,952 ha. Geographically it was laid between 115°13'12" - 116°05'24" eastern and between 00°1'12" - 00°09'00" southern. Graphically, the study area could be seen at Fig. 1.

It can be said that Kedangpahu watershed is the big watershed in East Kalimantan. If the rainfall is high in all over area of Kedangpahu the flood must occur in this area. It consists of seven sub watershed in succession; they are Idan 29,666.72 ha, Nyuatan 120,181.9 ha, Nyahing 64,083.09 ha, Kedangpahu 140,506.4 ha, Perak 70,540.69 ha, Lawa 113,654.42 ha, and Jelau 160,318.02 ha, graphically as shown in Figure 1. Jelau is the largest sub watershed among of them.

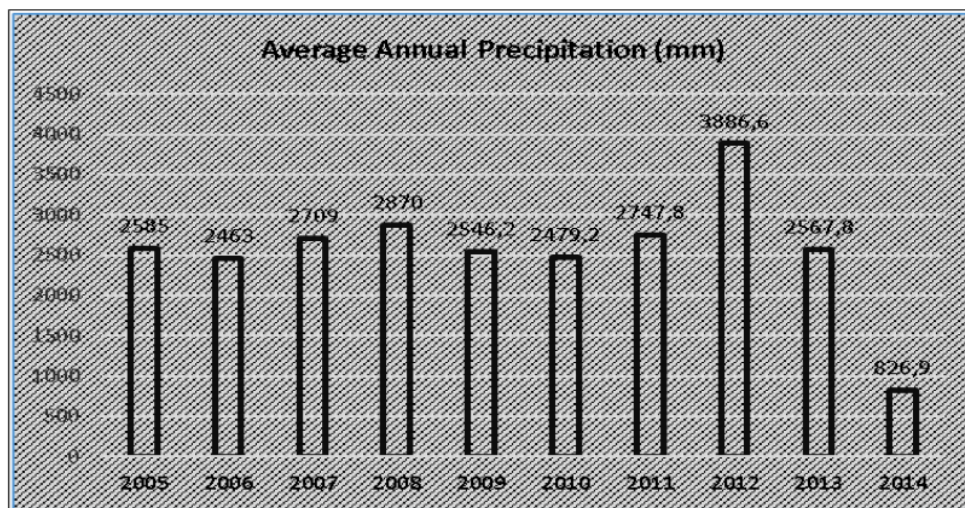
**Fig. 2.** Average annual precipitation.

Air temperature laid between 28,63°C to 27,24°C. The highest average relative humidity is 86.17% and the lowest 79.10%. Average precipitation is 2,568.2 mm/year with maximum 3,886.6 mm/year and minimum 826.9 mm/year as seen in Fig. 2. Base on this figure the highest one occur on the year of 2012. While monthly average precipitation could be seen in Fig. 3. Base on this figure the highest precipitation occur on December.

According to the results presented above, it can be said that Kedangpahu watershed covers a very large area of 698,952 ha which results in high quality of this river discharge. Geographically, the position is near the equator which means that precipitation at the study area is high with the average precipitation reaches 2,568.2 mm/year with maximum number of 3,886.6 mm/year. The highest precipitation occurred

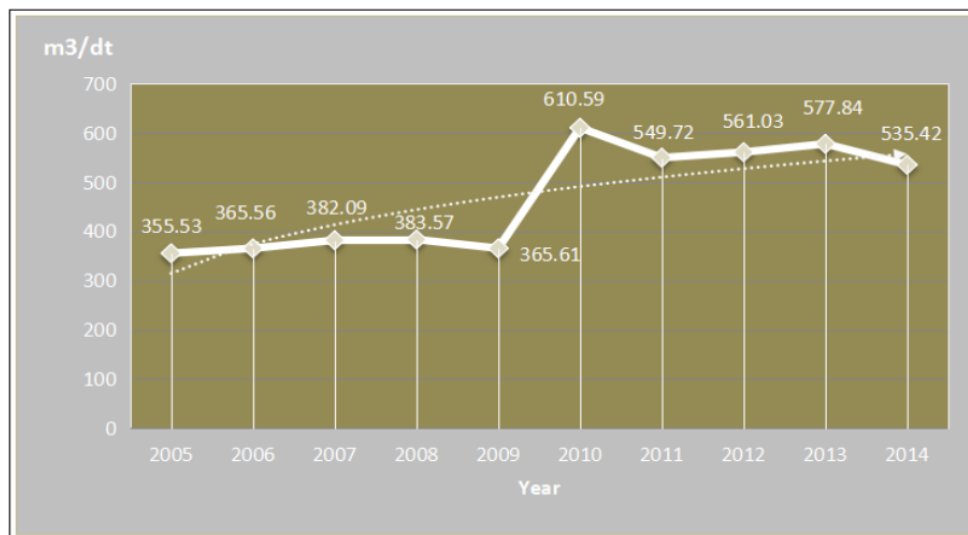
**Fig. 4.** Average discharge of lately ten years.

Discharge of Kedangpahu river for ten years later lays from 355.5 m<sup>3</sup> to 610.6 m<sup>3</sup>. Water regime index reaches 2.34 for 10 years later.

In general the condition of discharge can be seen at Figure 4. According to Figure 4 the discharge of Kedangpahu river tend to increase from year by year from 2004 to the year of 2014. While from Figure 3 could be seen the highest precipitation occurred at December.

on December, it means that the flood possibility occurred in December is high. During the days with precipitation reaches the highest point, flooding will occur. Year of 2012 precipitation data indicated the highest one. While monthly precipitation indicated that December was the highest point reaching 376.72 mm and occur until January. Discharge of Kedangpahu river in 2012 laid from 355.5 m<sup>3</sup> to 610.6 m<sup>3</sup>. Figure 4 indicated the trend of discharge which shows an increasing year by year.

It is linear with land cover degradation condition. Uncontrolled deforestation in sub watersheds increases discharge of Kedangpahu river. Average of water regime index of the last 10 years reached 2.34 point. It means that in arid season the water discharge lower than in rainy season. Al-Bakri *et al.* (2013) stated that problems of water security and food insecurity would be exacerbated by climate change and increased population growth. His study held in Jordan in relation to water and food security.
